ASTP FLIGHT READINESS REVIEW BOARD

VOL. II SPACECRAFT-ROCKWELL

APOLLO-SOYUZ TEST PROJECT
CSM 111/DM-2/DS 5/SLA 18
FLIGHT READINESS REVIEW
PREBOARD REPORT
JSC

4 JUNE 1975

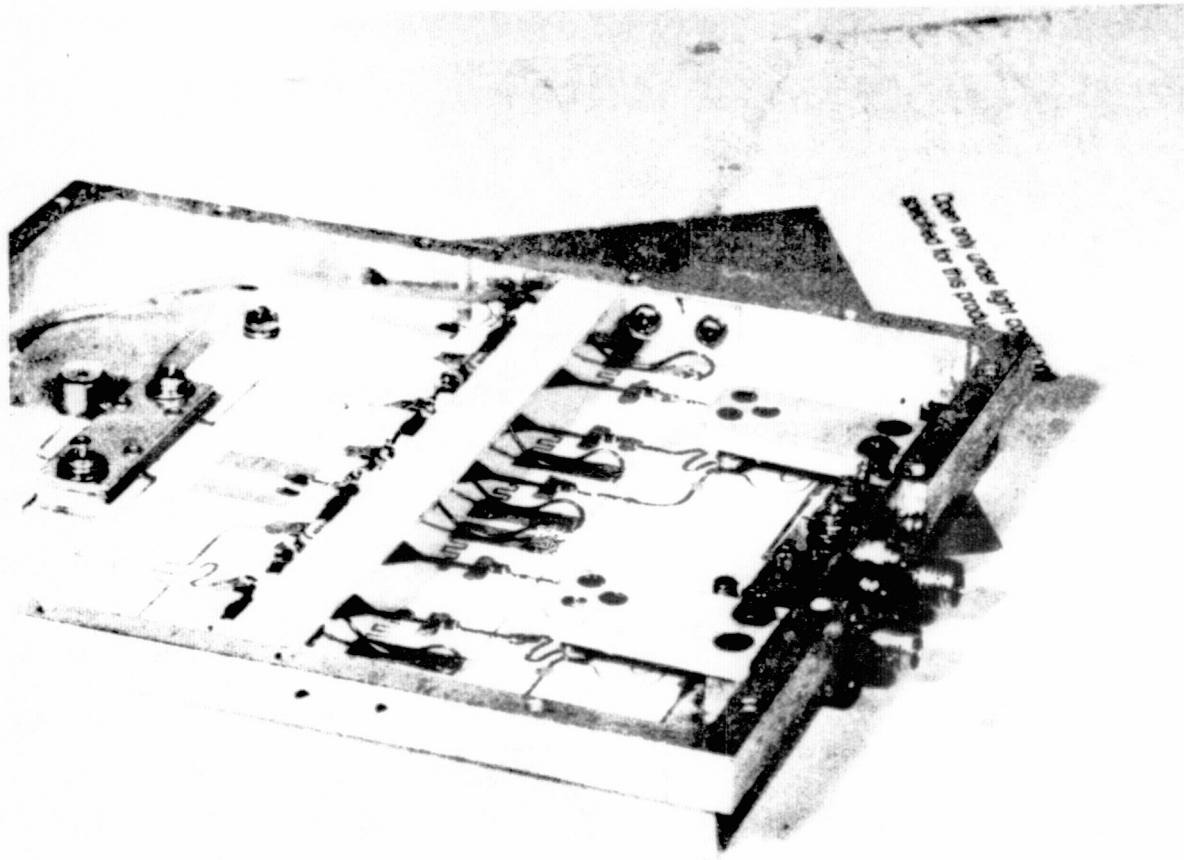
ATS-6 POWER AMPLIFIER BASIC AMPLIFIER MODULE

<u>SN</u>	<u>EVENT DESCRIPTION</u>	<u>PROBLEM CAUSE</u>	<u>RESOLUTION</u>
003	QUAL THERMAL - VAC FAILURE - PARTIAL LOSS OF RF OUTPUT	BROKEN SOLDER JOINT	RESOLDER TO NEW LOW STRESS SOLDER PROCEDURE
003	QUAL THERMAL-VAC FAILURE - LOSS OF RF OUTPUT & RECOVERY	PWR SUPPLY TRACE SHORT	ANALYSIS & TEST CONCLUDES TEST ENVIRONMENT OF UNGROUNDED INPUT CABLE
005	QUAL THERMAL-VAC FAILURE - INCREASE INPUT CURRENT WITH NOISE	SHORTED TRANSISTOR COLLECTOR TO CHASSIS	ANALYSIS & TEST CONCLUDES KAPTON INSULATOR SHORT THRU HOLE

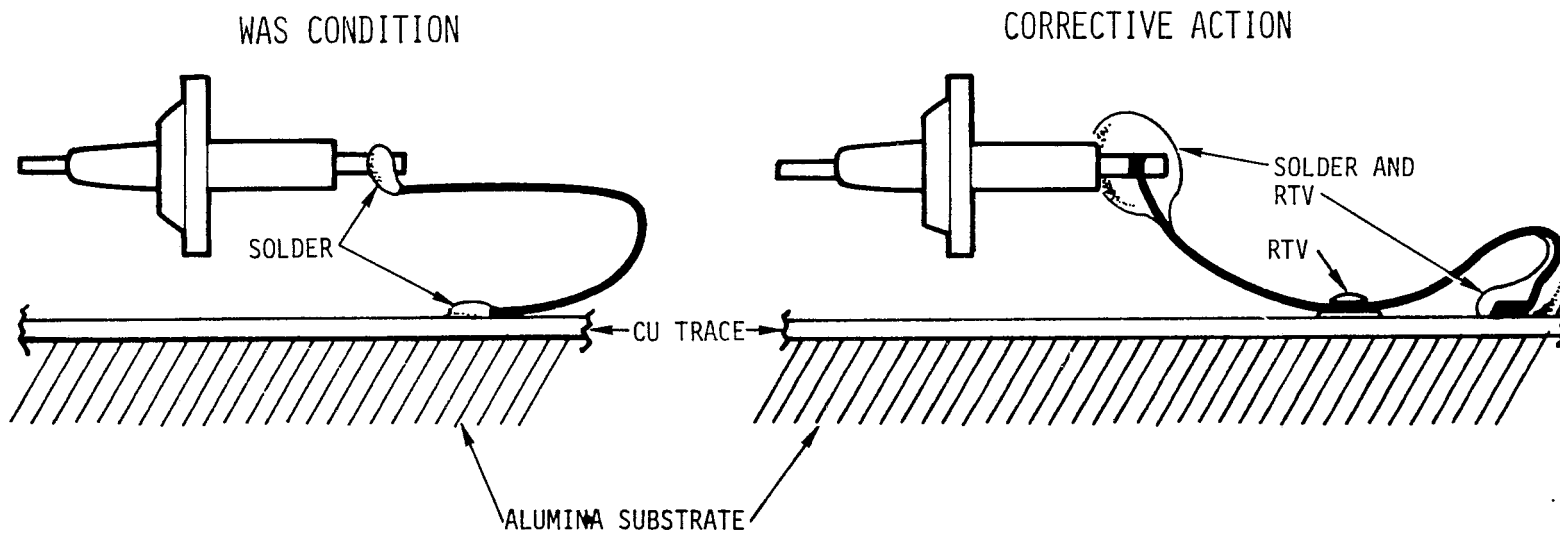
B+ LEAD INSTALLATION

<u>SN</u>	<u>EVENT DESCRIPTION</u>	<u>PROBLEM CAUSE</u>	<u>RESOLUTION</u>
003	QUAL VIBRATION FAILURE - 3 BROKEN B+ WIRES	LOOSE TERMINAL LOAD, B+ WIRE FATIGUE FAILURE, & PWR SUPPLY COMPONENTS LOOSE	CORRECTIVE STAKING POTTED POWER SUPPLY
003	QUAL VIBRATION FAILURE - RESISTOR MOUNTING BLOCK FAILURE	LACK OF STAKING & MARGINAL DESIGN	REDESIGN SUBSTITUTE DELRIN FOR TEFLON
001	PS DYNAMIC FAILURE OUTPUT VOLTAGES ERRATIC (LOST VOLTAGE REGULATION)	LOOSE TERMINAL (IMPROPERLY STAKED)	REPAIRED PWR SUPPLY & CONCLUDED QUAL DYNAMIC TEST

ATS-6 POWER AMPLIFIER VIBRATION TEST FAILURE

- POT FINAL AMPLIFIER B+ TERMINATIONS WITH RTV & RTV LEAD CENTER TO SUBSTRATE BASE

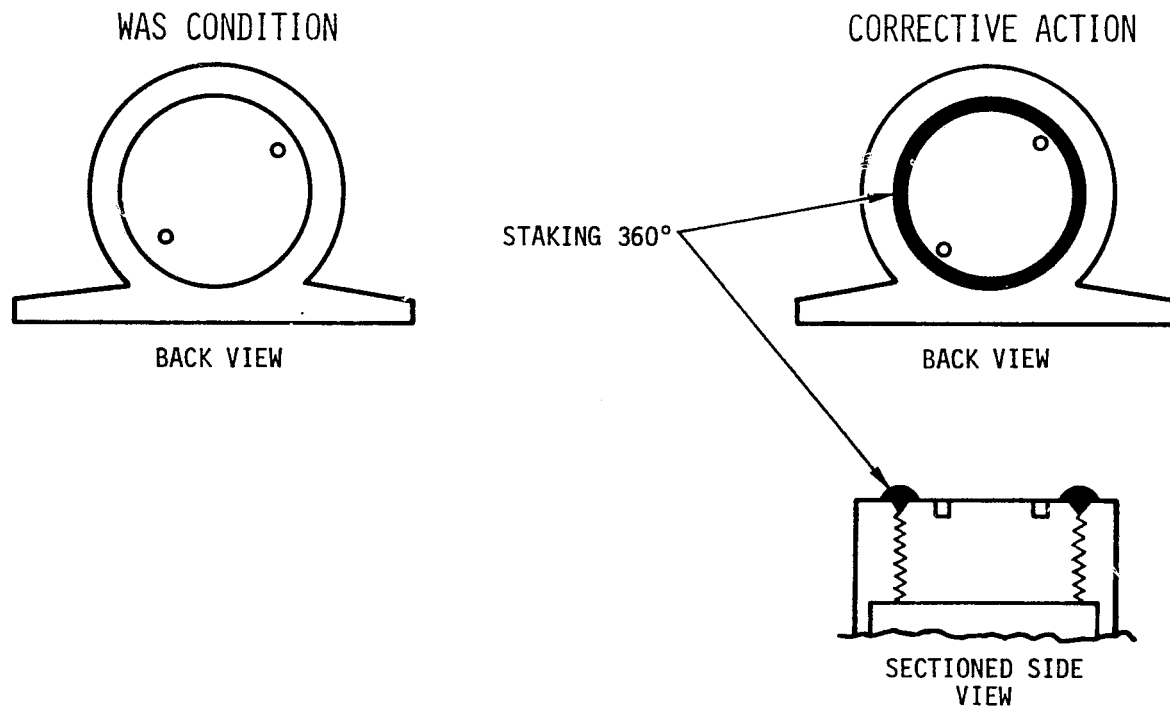
LOOSE COMPONENTS

ATS-6 POWER AMPLIFIER VIBRATION TEST FAILURE

- RE-REVIEW POWER AMP SOLDER JOINTS & COMPONENTS FOR VIBRATION SENSITIVITY
- STAKE BOTH RF TERMINAL LOAD INSERTS

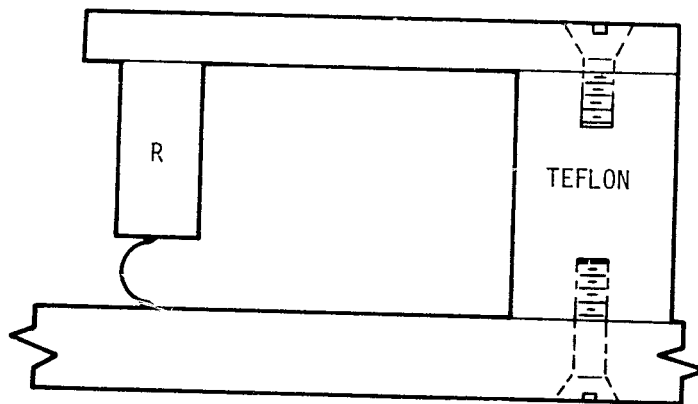
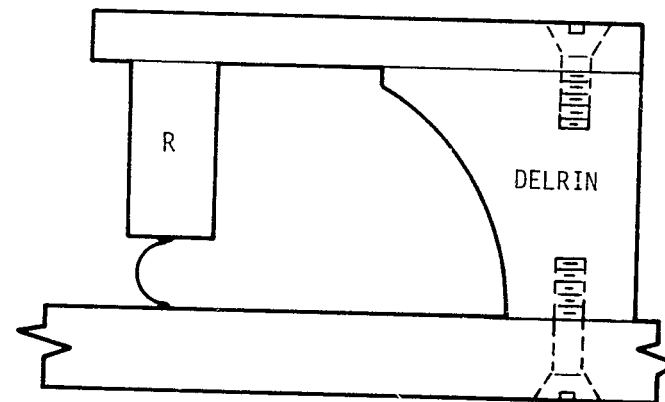
RESISTOR TERMINATION BLOCK

ATS-6 POWER AMPLIFIER VIBRATION TEST FAILURES

- USE DELRIN WITH IMPROVED CROSS SECTION
- DIMENSIONALLY CONTROL HELICOIL INSERT
- STAKE MOUNTING SCREWS
- VERIFY BY OFF-LIMIT VIBRATION TESTING

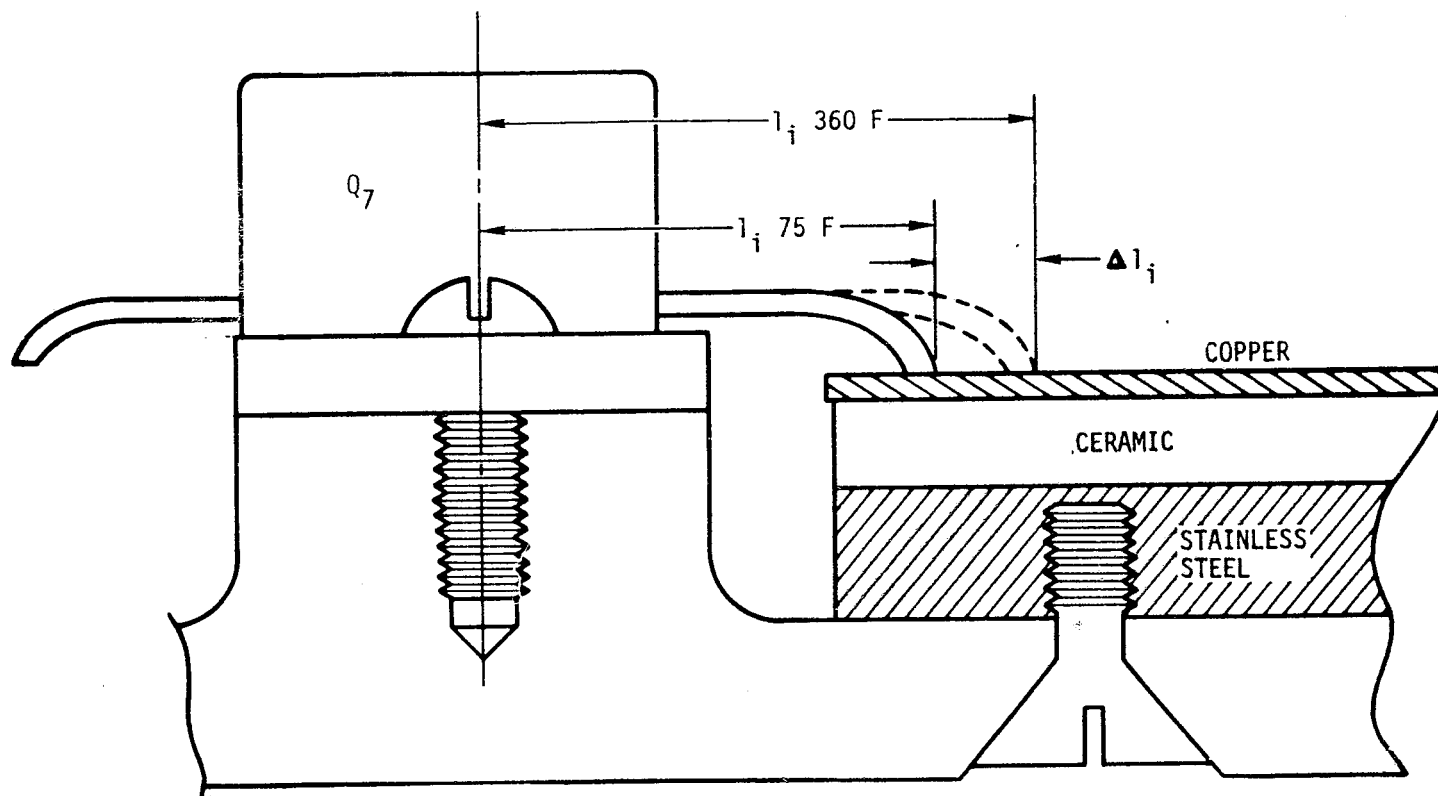
ATS-6 POWER AMPLIFIER BASIC TRANSISTOR INSTALLATION

- TEARDOWN INSPECTION REVEALED BROKEN SOLDER CONNECTION AT ONE BASIC AMPLIFIER MODULE (OUTPUT HYBRID)
- SOLDER JOINT 20 POWER INSPECTION REVEALED SEVERAL CRACKED JOINTS
- FLIGHT UNITS 20 POWER INSPECTED AND CRACKED JOINTS IDENTIFIED
- SOLDER JOINT STRESS ANALYSIS REVEALED MARGINAL JOINT CONFIGURATION WITH SAFETY FACTOR <1.0

- TRIM, FORM, PRETIN, AND INSPECT COMPONENT LEADS FOR POSITIVE CONTACT TO TRACE
- FORM LEADS TO PROVIDE STRESS RELIEF
- INSTALL COMPONENTS WITH LOCATING PINS TO CENTER
- SOLDER ONE SIDE, AFTER COOLING LOOSEN MOUNTING SCREW AND ALLOW BUILT-IN STRESS TO RELIEVE TO ZERO
- TIGHTEN SCREW AND SOLDER OTHER SIDE - LOOSEN SCREW AND PERMIT LEAD STRESS TO EVENLY DISTRIBUTE TO BOTH LEADS
- TORQUE MOUNTING SCREW AFTER COOL DOWN
- ADDED HIGH TEMPERATURE STRESS RELIEF BY SOLDERING AT ELEVATED TEMPERATURE OF 43 DEG C

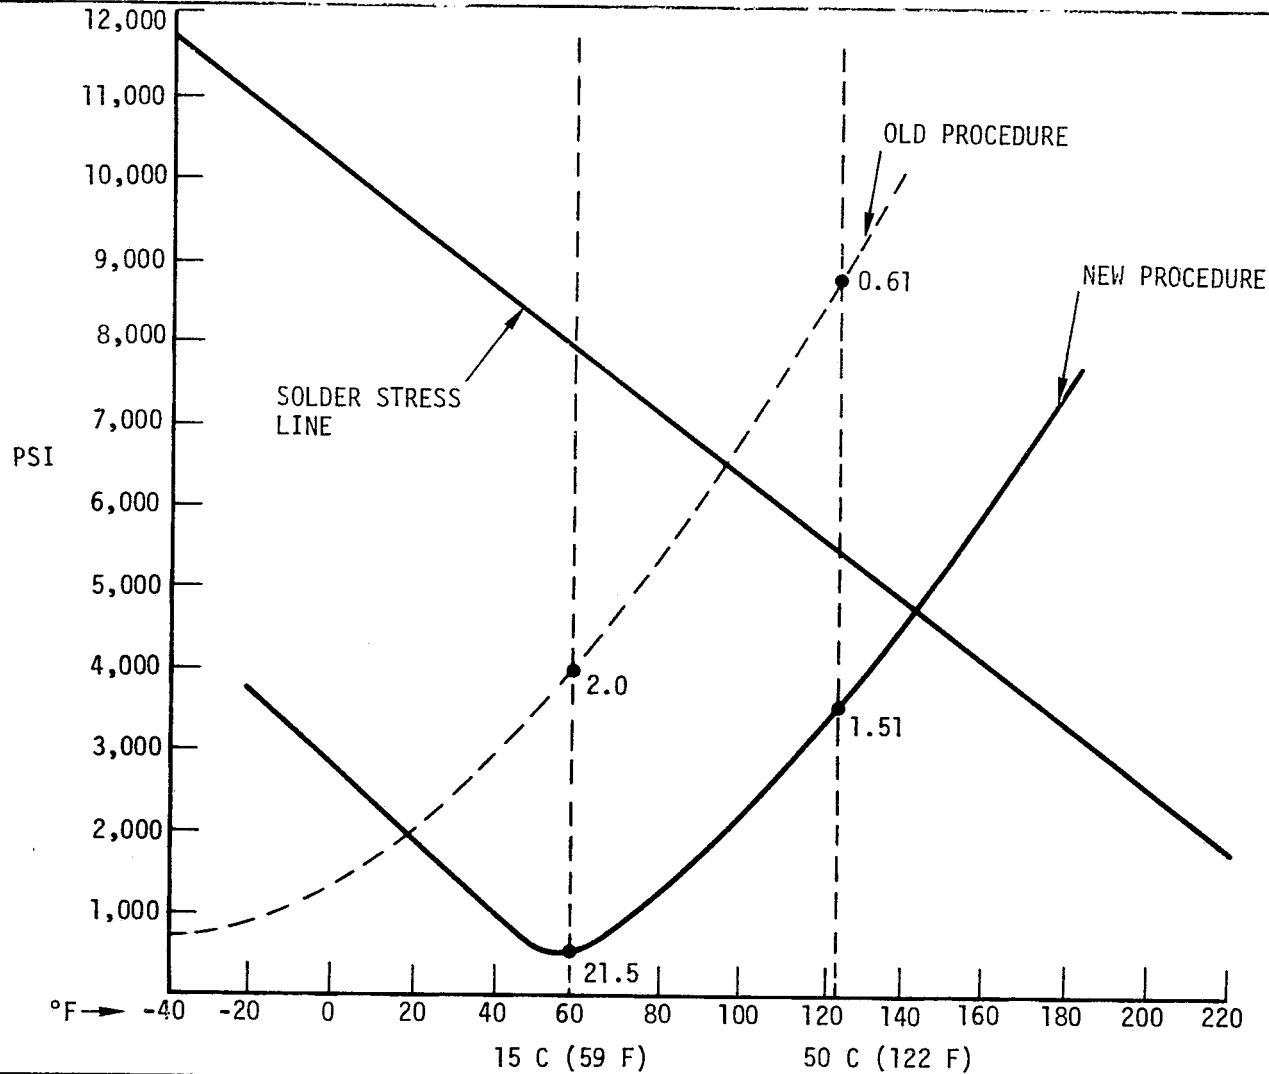
ATS-6 PA BASIC AMPLIFIER
 TRANSISTOR LEAD - COLLECTOR (NARROW LEAD)
 LEAD STRENGTH VERSUS SOLDER STRENGTH UNDER THERMAL STRESS

COMPONENT	BASELINE			
	AT 15C		AT 50C	
	OLD	NEW	OLD	NEW
BASIC AMPLIFIER				
Q ₇ , Q ₂ COLLECTOR LEADS	2.0	21.5	0.61	1.51
Q ₇ , Q ₂ EMITTER LEADS	2.3*	1.48*	0.69	2.30
HYBRID LEADS	2.2*	3.9*	0.66	1.87
INTERMEDIATE-LEVEL AMPLIFIER				
COLLECTOR LEADS	3.8*	4.1*	0.94	2.8
LOW-LEVEL AMPLIFIER				
CONNECTOR LEADS	4.0	9.3	2.3	3.86
TRANSISTOR LEADS	12.8	-	5.4	-

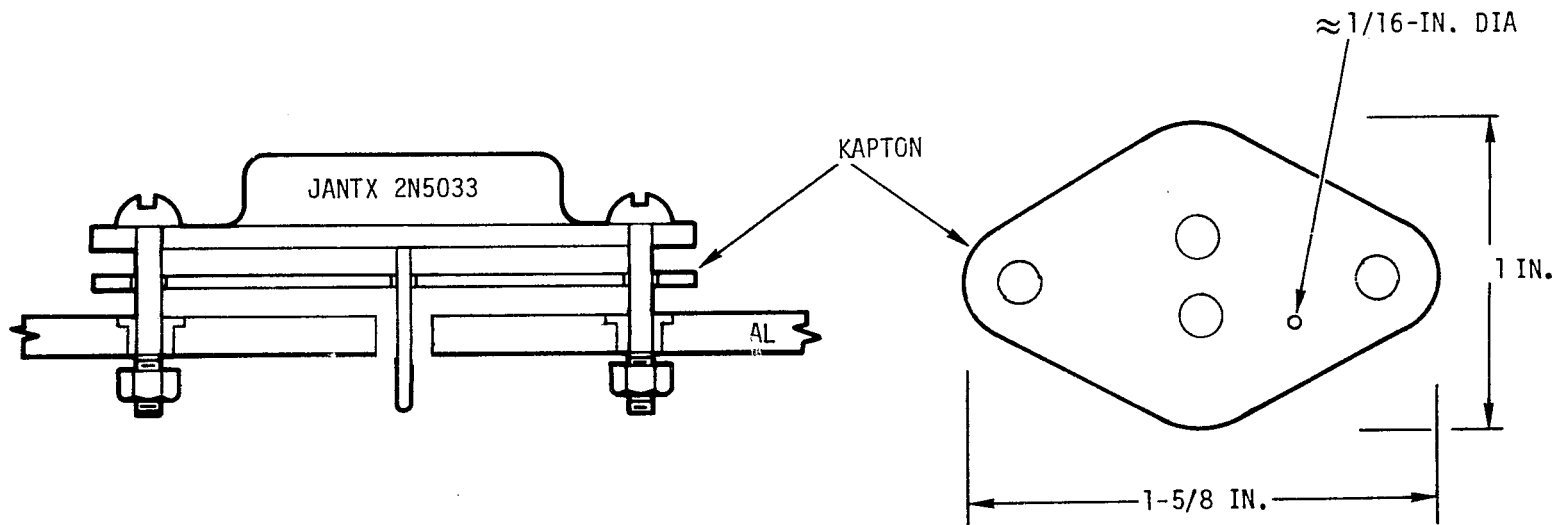
ATS POWER SUPPLY:
KAPTON HOLE

- FAULT IN THE POWER SUPPLY - THE POWER SWITCHING TRANSISTOR Q₆ COLLECTOR (CASE) WAS FOUND SHORTED TO CHASSIS WITH A CHARRED HOLE IN THE KAPTON 2 MIL INSULATOR AND ARC PITTING ON BOTH TRANSISTOR AND MOUNTING BRACKET SURFACES

- KAPTON SHORT CAUSED BY ARCING POTENTIAL DUE TO CHARGE POTENTIAL ON INPUT POWER LINES ACROSS HOLE IN KAPTON
- ARCING UNIQUE TO QUAL TEST SETUP
- CSM INSTALLATION GROUNDED - THEREFORE SATISFACTORY

- DESIGN FUNCTIONALLY ADEQUATE AND CONSERVATIVE
- DESIGN DEFICIENCIES CORRECTED
 - OUTPUT VOLTAGE TRANSIENT AT TURN-ON
 - MECHANICAL SENSITIVITY TO VIBRATION
- CONFIDENCE INCREASED BY POWER SUPPLY REBUILD PROGRAM
 - REBUILD THREE FLIGHT POWER SUPPLIES
 - REUSE ONLY INDUCTORS, TRANSFORMERS, AND INPUT FILTER AND BRACKET HARDWARE
 - ALL ELECTRONIC PARTS IDENTICAL TO INITIAL BUILD

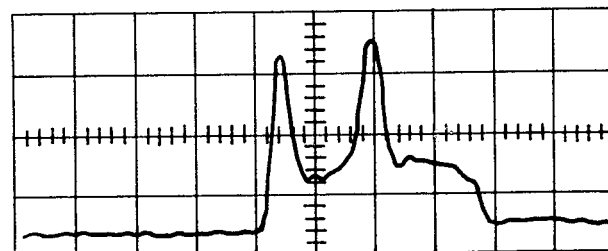
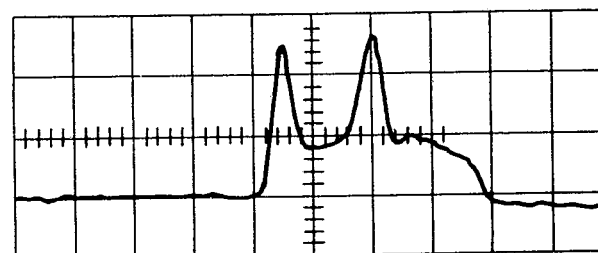
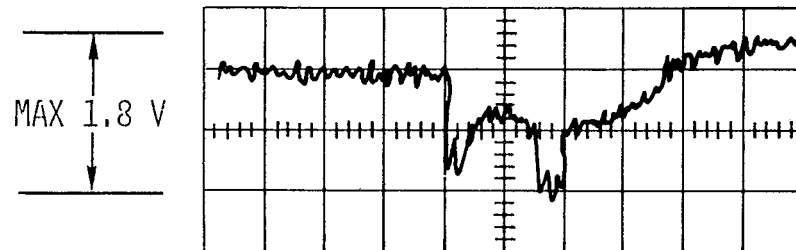
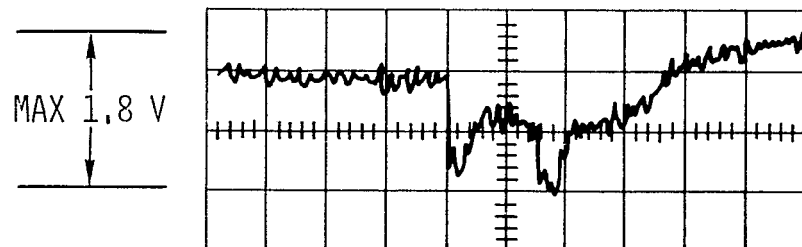
FRRID 111.2.8.2 (CONT)
MAIN BUS A AND B CURRENT GLITCHES

- UNABLE TO DETERMINE EXACT CAUSE OF CURRENT GLITCH
- MOST PROBABLE CAUSE IS FAILURE OF FILTER CAPACITOR IN ONE OF LOADS PREVIOUSLY IDENTIFIED
 - MOST LIKELY UNIT IS ATS-6 PA, SINCE GLITCH IN RECEIVER SIGNAL STRENGTH WAS NOTED AT SAME TIME AS CURRENT GLITCH
 - ANALYSIS OF PA SHOWED THAT MOST LIKELY FAILURE WAS FILTER CAPACITOR IN PA POWER SUPPLY
 - POWER SUPPLY CAPACITOR INSPECTION AND DISSECTION DID NOT SHOW EVIDENCE OF SHORT
 - IF PROBLEM WOULD OCCUR IN FLIGHT, SWITCH TO REDUNDANT PA

- ALL POWER SUPPLIES FOR FLIGHT PA'S WILL BE REPLACED WITH REBUILT UNITS

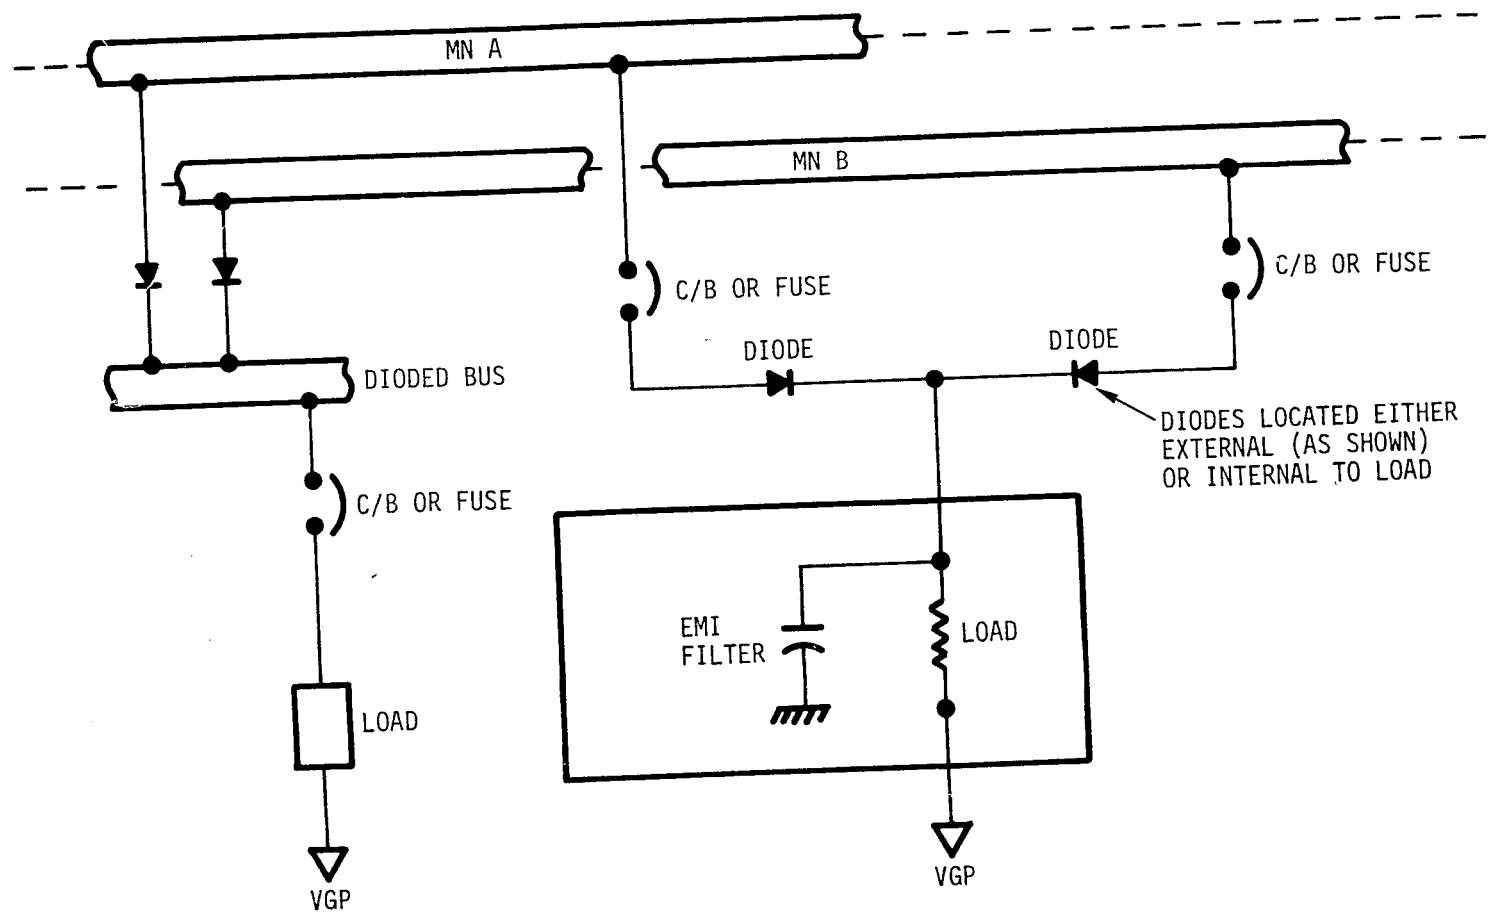
TYPICAL DIODED LOADS

- ANALYZED CURRENT AND VOLTAGE DATA TRACES
 - INDICATED SHORT WAS IN DIODED LOAD
- IDENTIFIED AND ANALYZED ALL ACTIVATED DIODED LOADS FOR POTENTIAL CAUSE
- ESTABLISHED FAILURE CONDITIONS FOR ANALYSIS
 - SEPARATE WIRES FROM MN A & MN B MOMENTARILY & SIMULTANEOUSLY SHORTING TO STRUCTURE OR NEGATIVE
 - REJECTED AS TOO REMOTE A POSSIBILITY
 - SINGLE WIRE IN DIODED CIRCUIT MOMENTARILY SHORTING TO STRUCTURE OR NEGATIVE
 - REMOTE POSSIBILITY - DIFFICULT TO VISUALIZE A SHORT MECHANISM THAT WOULD PRODUCE TWO 59 AMP SPIKES AND RETURN TO APPROX. 20 AMPS AFTER EACH SPIKE
 - PAST EXPERIENCE HAS BEEN THAT WIRE SHORT IS LOW-IMPEDANCE SHORT THAT CAUSES CIRCUIT PROTECTIVE DEVICE TO OPEN

- ESTABLISHED FAILURE CONDITIONS FOR ANALYSIS (CON'T)
 - LOAD FAILURE IN DIODED CIRCUIT
 - NOT A POSSIBLE CAUSE - ALL LOADS ENERGIZED DURING ANOMALY HAVE BEEN VERIFIED TO PERFORM SATISFACTORILY DURING AND SUBSEQUENT TO ANOMALY
 - COMPONENT FAILURE IN DIODED LOAD
 - POSSIBLE - FAILURE OF A FILTER CAPACITOR COULD HAVE CAUSED ANOMALY
 - EXACT MECHANISM OF CAPACITOR FAILURE THAT COULD PRODUCE SUBJECT GLITCH IS UNKNOWN
 - SHORT IN GSE CIRCUITS
 - GSE SPACECRAFT POWER CIRCUITS ELIMINATED SINCE LOCATION OF CURRENT MEASUREMENTS VERIFIES THAT FAULT CURRENT OCCURRED IN SPACECRAFT
 - OUTPUT TO GSE FROM DIODED LOADS LIMITED TO CRYO PRESSURE LOW INDICATION
 - GSE WIRING INSPECTED AND MEGGERED
 - NO SUSCEPTIBLE COMPONENTS IN CIRCUITS - FIRST COMPONENT IS 100K RESISTOR

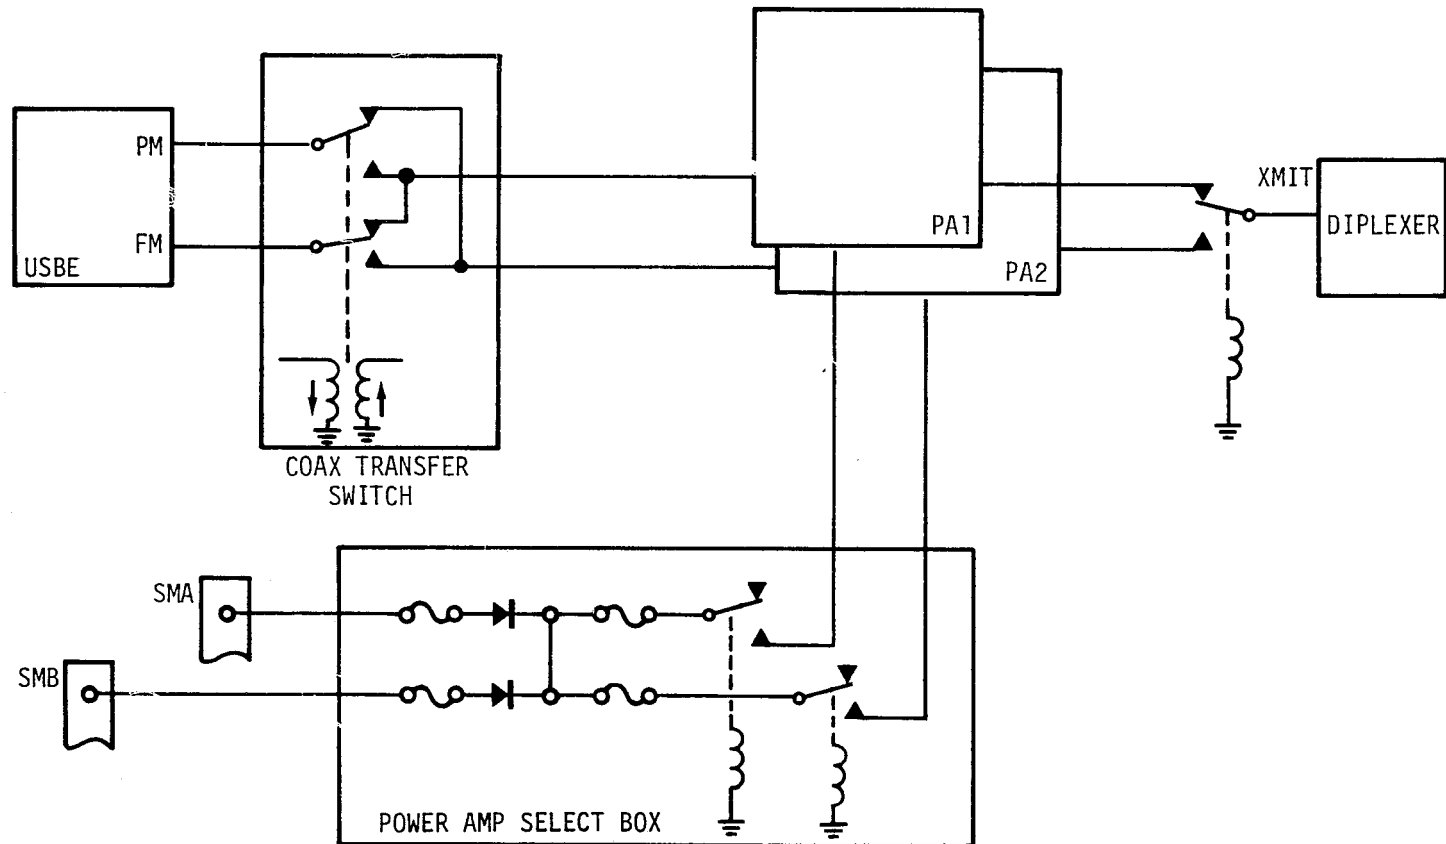
FRRID 111.2.11.2 (CONT)
ATS-6 POWER AMPLIFIER POWER OUTPUT

- ATS-6 S-BAND POWER AMPLIFIER DELAY IN COMING ON FOLLOWING APPLICATION OF DC POWER AND RF DRIVE (UNEXPLAINED ANOMALY)
 - BOTH PA'S EXPERIENCED PROBLEM
 - 8 IDENTIFIED OCCURRENCES, PA NO. 1
 - 3 IDENTIFIED OCCURRENCES, PA NO. 2
 - RF OUTPUT APPROX. 35 dB BELOW NORMAL AND DC CURRENT 1 TO 2 AMPS VS 10 AMPS NORMAL
 - PROBLEM OCCURRED IN PM MODE ONLY
 - SELF-CLEARED, WITHIN APPROX. ONE MINUTE, OR WAS CLEARED BY SWITCHING TO OTHER AMPLIFIER (OR OFF) MOMENTARILY OR BY SWITCHING TO FM DRIVE

- INITIAL CIRCUIT ANALYSIS AND DATA REVIEW SUGGESTED THE FOLLOWING POSSIBLE CAUSES:
 - HANGUP IN COAX TRANSFER SWITCH
 - HANGUP IN RELAY K-1 IN PANEL 230
 - FAULTY POWER CONTROL RELAYS IN TRANSMITTER SELECT BOX
 - PROBLEM WITHIN THE POWER AMP ITSELF
- COAX TRANSFER SWITCH REPLACED
 - PROBLEM RECURRED WITH NEW TRANSFER SWITCH
- INSTALLED VOM'S TO MONITOR COMMANDS TO COAX TRANSFER SWITCH
 - PROBLEM RECURRED WITH NORMAL COMMANDS
- INSTRUMENTED INPUT DC POWER, INPUT AND OUTPUT RF POWER OF EACH PA
 - PROBLEM RECURRED WITH INPUT DC OK, INPUT RF POWER OK
- INTERMITTENT COAX CONNECTOR FOUND AND REPAIRED (PM RF TRANSFER SWITCH COAX CABLE)
 - HANGUP NEVER AGAIN OCCURRED
 - COAX WOULD NOT EXPLAIN PROBLEM SINCE HANGUP OCCURRED WITH PROPER RF DRIVE

- HANGUP CAUSES AND MECHANISMS POSTULATED AND ELIMINATED BY TEST
 - EMI INDUCED POWER AMP POWER SUPPLY HANGUP IN LOW OUTPUT VOLTAGE MODE
 - AC VOLTAGES COUPLED INTO SPACECRAFT INTERFACE WIRING - NO HANGUP OCCURRED
 - INDUCTANCE IN DC SUPPLY WIRING MAY HAVE CAUSED POWER AMP POWER SUPPLY OSCILLATION AND REDUCED DC OUTPUT
 - CALCULATIONS SHOW ABOUT 12 MICROHENRY EACH IN SUPPLY AND RETURN WIRES AND BETWEEN CASE AND VGP
 - TESTS WITH 20 AND 100 MICROHENRY IN EACH CAUSED NO OSCILLATION OR REDUCED RF OUTPUT
- ANALYSIS BY POWER SUPPLY CONSULTANT FAILED TO IDENTIFY POSSIBLE HANGUP MECHANISM
- NO HANGUPS OBSERVED DURING EXTENSIVE TESTING OF FLIGHT AND ENGINEERING MODEL POWER AMPLIFIERS
